Southeastern Minnesota Center for Independent Living, Inc. Accessibility Assessment Findings and Improvement Options

Property of: **First Unitarian Universalist Church - Rochester**
Address: **1727 Walden Lane Southwest**
Rochester, MN 55902-0901

Conducted On: **September 2, 2015**
SEMCIL Staff: **Robert Weigel, Accessibility Specialist**

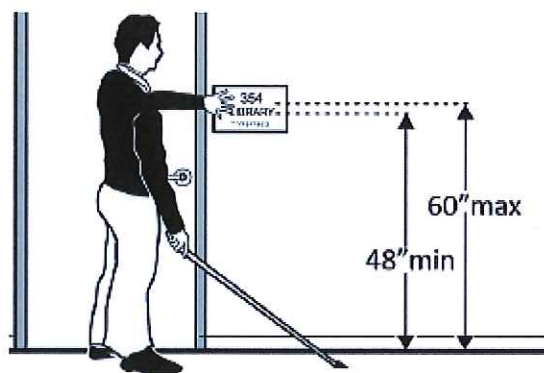
Figure 1

There are signs with words directing drivers to the accessible parking area but these signs do not use the International Symbol of Accessibility. Using the symbol is recommended for recognizing the area.

- Provide signage for directing people to the accessible exit using the International Symbol of Accessibility (fig. 1) with raised/brail lettering at a height between 48" and 60" to the lettering (fig. 2).
- Use lever handle door knobs to provide better accessibility
- Grind or replace concrete to provide a smooth traveling surface
- Install ramp side flares or edge protection on the ramp to eliminate the risk of falling off the side of the ramp (fig. 3)

- Provide signage using the International Symbol of Accessibility (fig. 1) to direct people to the accessible parking area.
- Repaint lines at main entrance so that there is at least 3 accessible spaces on level ground. Spaces should be at least 96" wide with a 96" wide access zone (fig. 7). Two spots can share one access zone. At least one spot must be van accessible with the access zone on the passenger side.
- Provide accessible parking signs in front of the parking spots a minimum of 60" above the ground (fig. 8).
- Provide "No Parking" signs designated for the access aisles.

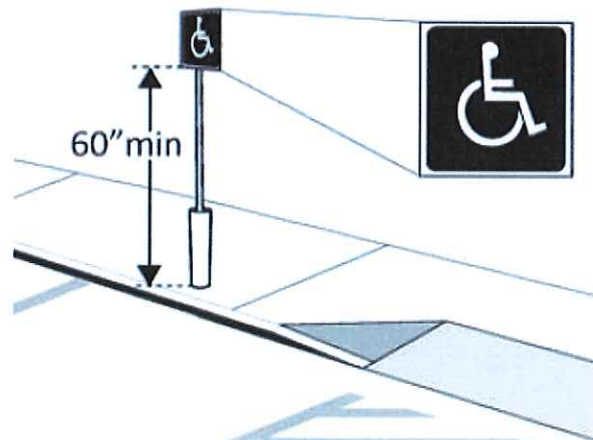
Figure 7

The main parking lot is located at the base of the building requiring individuals to climb a series of steps to reach the entrance. There are 3 marked accessible parking spaces provided near the buildings entrance. There are a total of 71 parking spaces for the building. Given the total number of parking spaces, 3 would be required to be accessible with at least one being van accessible. The accessible spots are 12' wide without marked access aisles. Accessible parking spaces should be a minimum of 96" wide with access aisles of at least 96" wide. The accessible parking space should be located on a surface with a slope no steeper than 1:48.
